Total Land Subsidence in the Ranegras Valley, La Paz County
Based on Radarsat-2 Satellite Interferometric Synthetic Aperture Radar (InSAR) Data
Time Period of Analysis: 1.0 Years 03/17/2014 To 04/05/2015

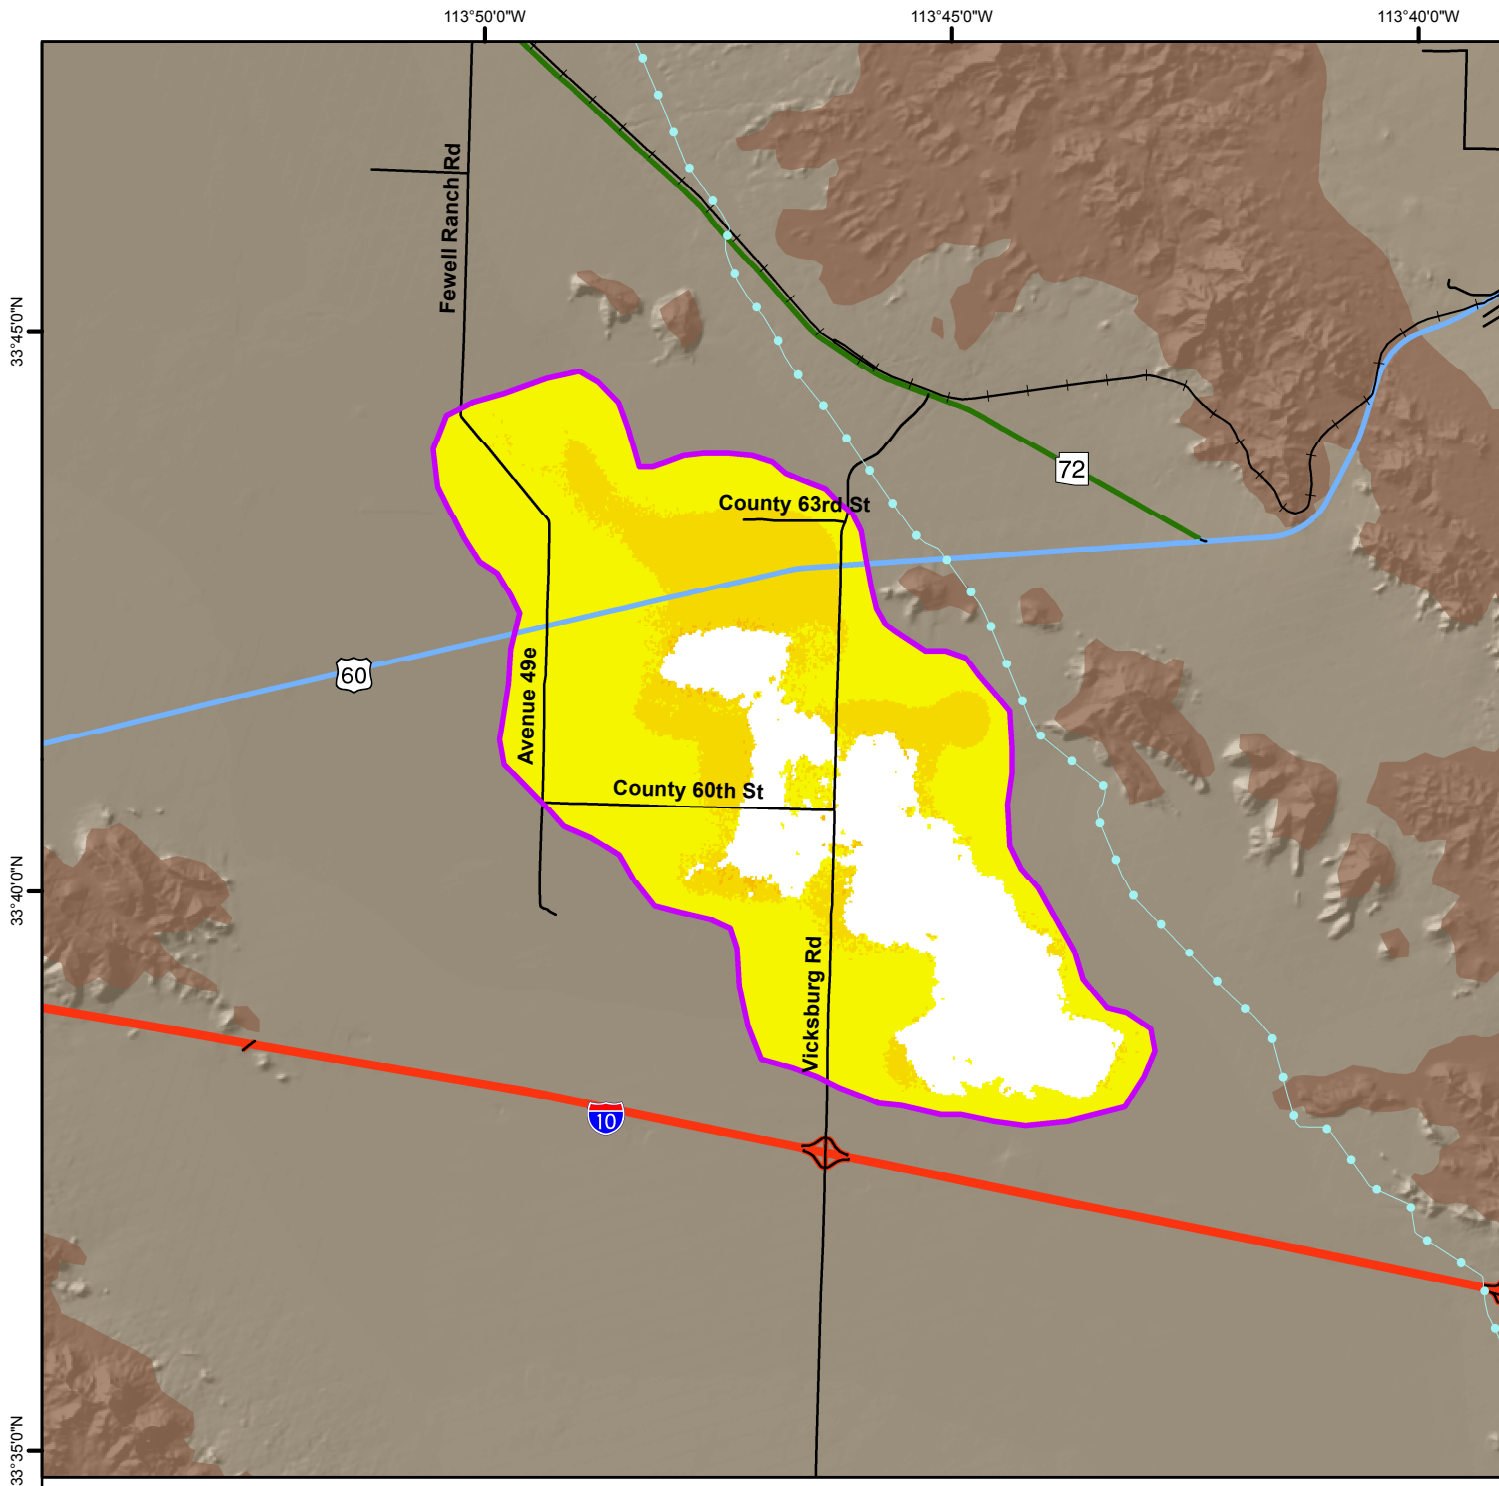
Decorrelation (white areas) are areas where the phase of the received satellite signal changed between satellite passes, causing the data to be unusable. This occurs in areas where the land surface has been disturbed (i.e. bodies of water, snow, agriculture areas, areas of development, etc).
